MISCELLANEOUS PAPER S-74-25 ✓

INVESTIGATION OF TAR-RUBBER PAVEMENT OVERLAYS

Philip J. Vedros, Jr., Ralph D. Jackson

November 1974

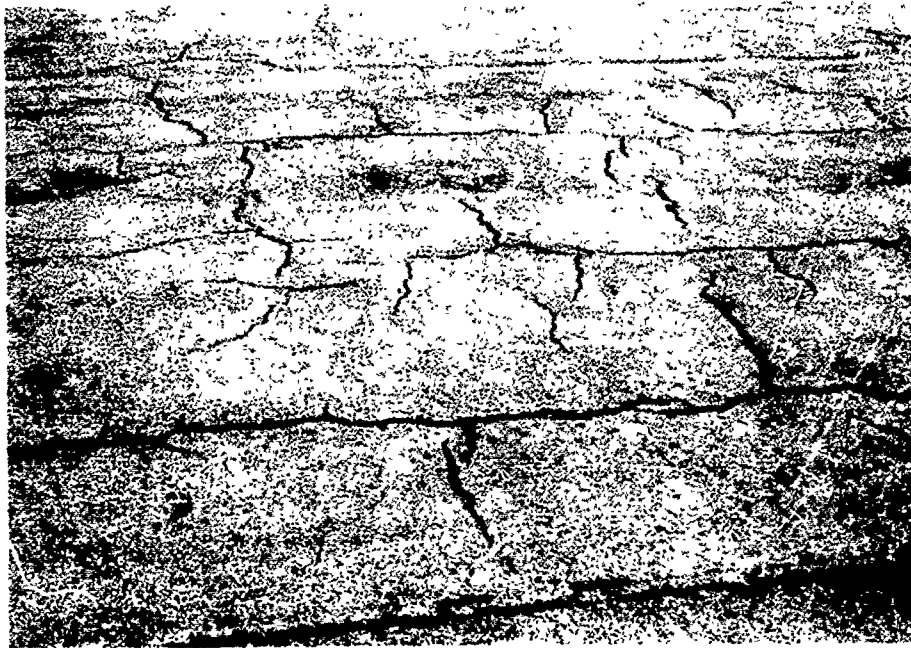
fighter-type aircraft (F-106 and F-4) have used the 1967 pavements. At the time of this investigation, the 1955 tar-rubber pavements were in poor to fair condition with considerable cracking (Photo 1) and roughness occurring adjacent to the cracks (Photos 2 and 3). The pavements began cracking approximately 2 years after placement and have progressively deteriorated over the years. Rutting was occurring in the taxiway area of the apron (Photo 4). In areas where the F-106 and F-4 aircraft had been parking on the 1967 tar-rubber pavements, the surface had depressed and ponding of fuel and hydraulic fluid in these areas had caused the surface to deteriorate to the point that removal of the pavement was necessary. At the time of this investigation, most of the 1967 tar-rubber pavements had been removed and replaced with PCC pavement. The core samples of the 1967 pavements obtained in this investigation were from small areas of pavement that had not been removed and that were not being used by aircraft.

Photo 1. Block cracking in Homestead (1955) pavement

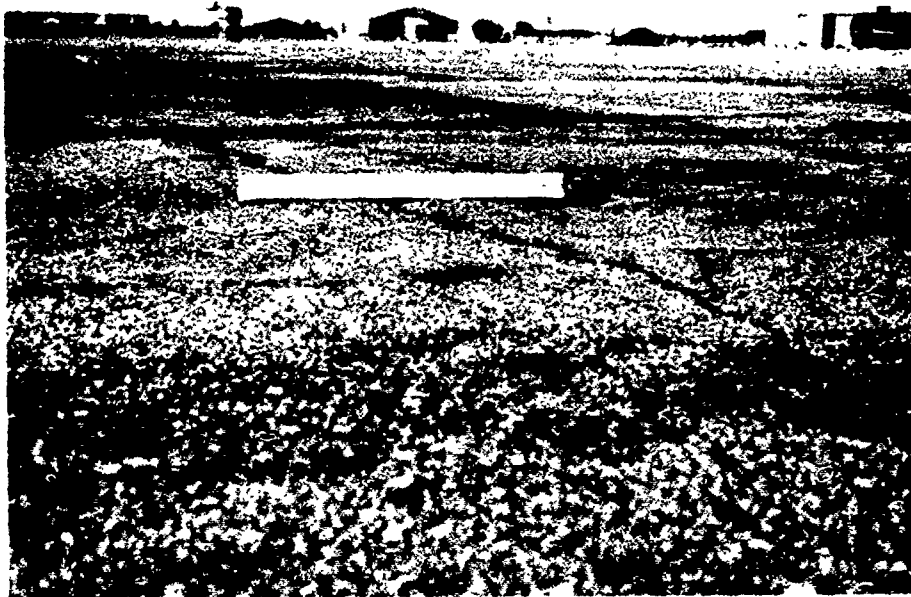
Photo 2. Unevenness on surface of Homestead (1955) pavement from cracking

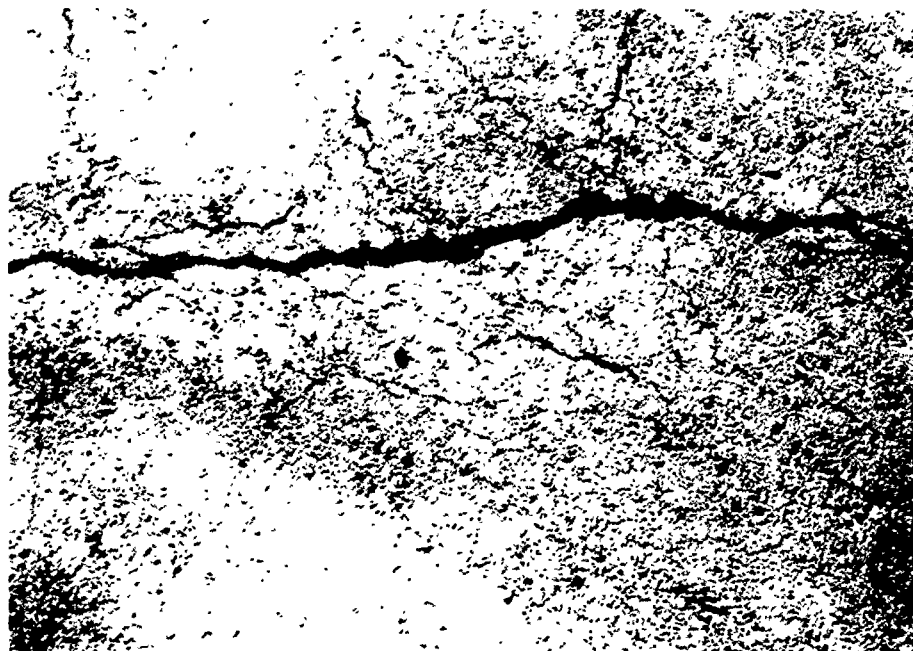
Photo 3. Slight depression at cracks
in Homestead (1955) pavement

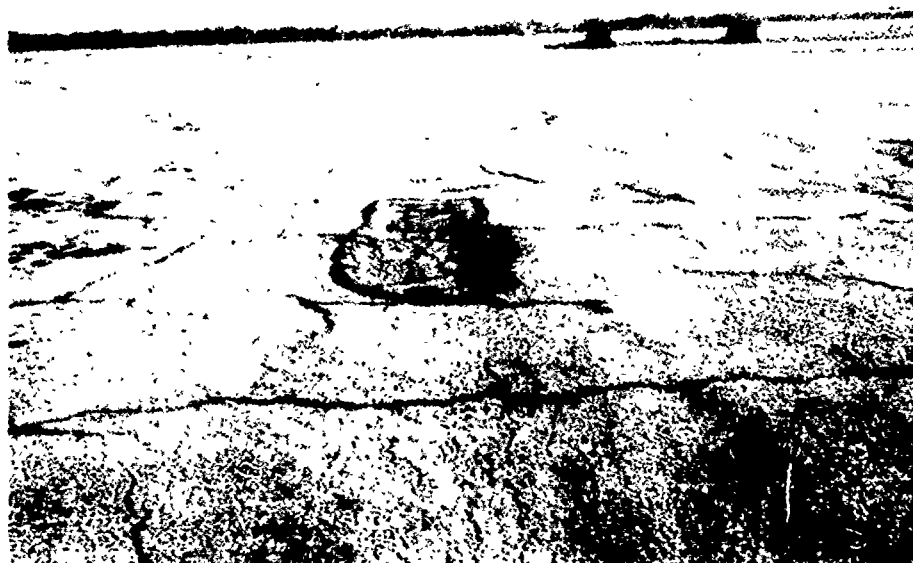
Photo 4. Rutting in taxiway on apron area
of Homestead (1955) pavement

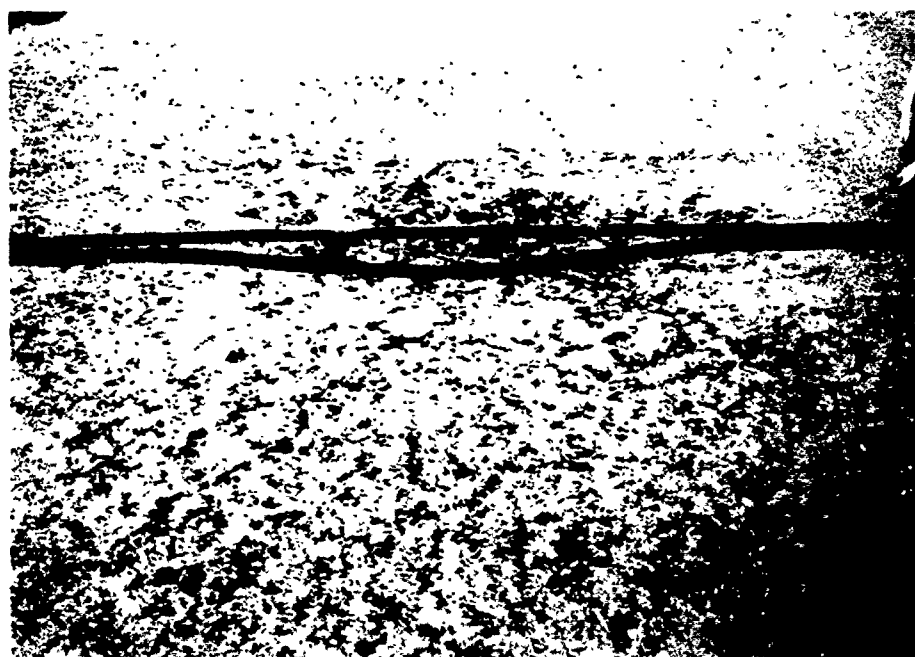
Photo 6. Pavement depression about $\frac{3}{4}$ in. deep in MacDill (1971) pavement

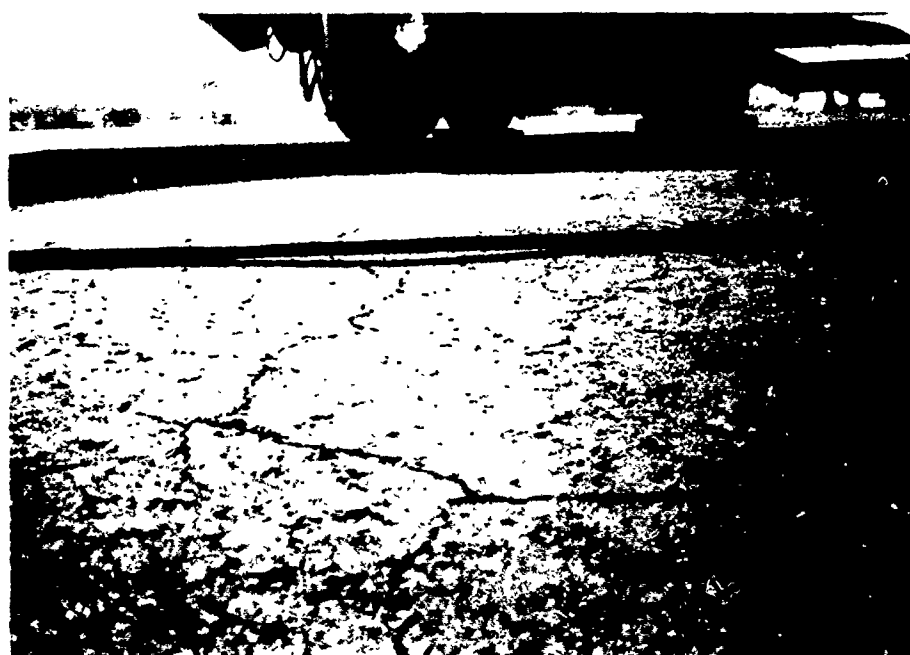
Photo 8. Ruts up to 1 in. deep in taxiway area
of MacDill (1971) pavement

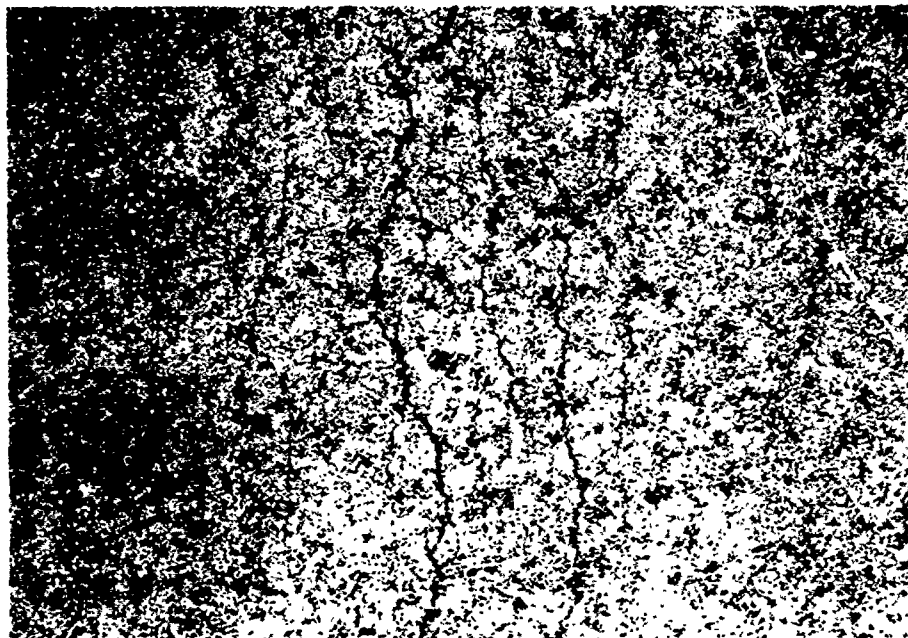
Photo 9. Longitudinal cracking in MacDill (1971) taxiway

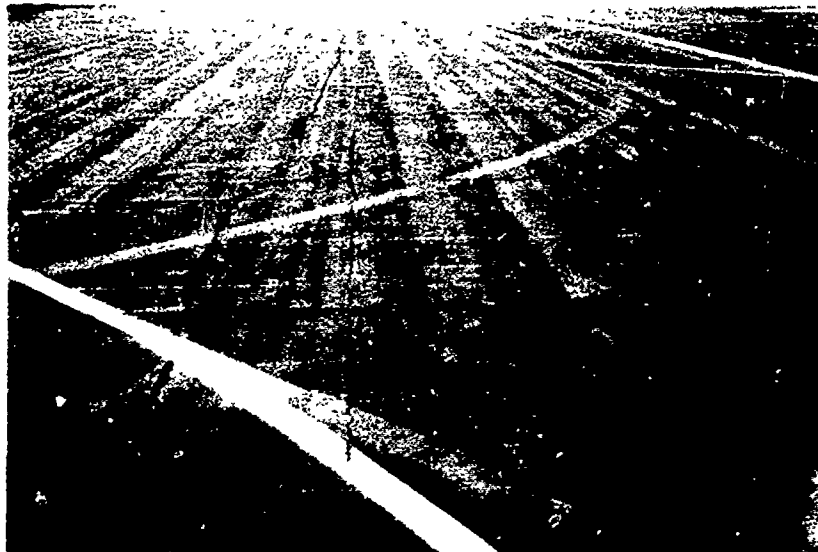
Photo 15. Construction joints and reflection cracking
in surface of Selfridge (1971) pavement

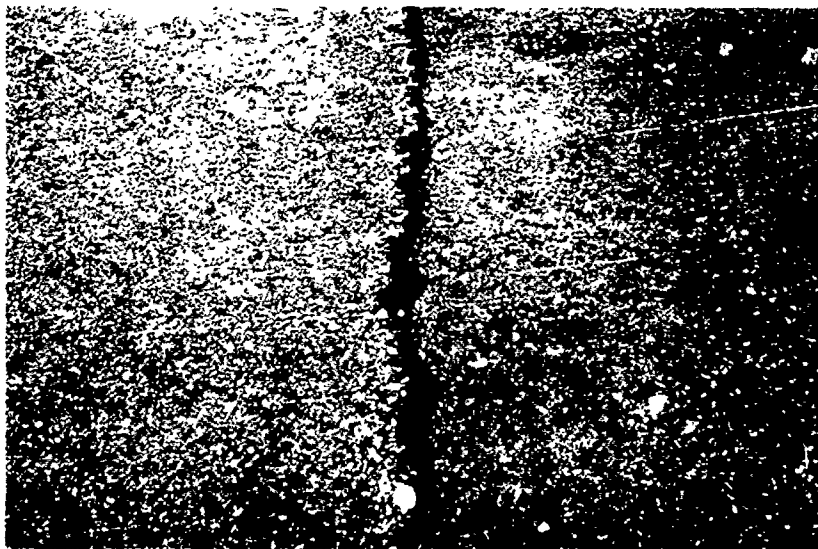
Photo 16. Selfridge (1971) pavement reflection crack
showing signs of raveling and needing sealing

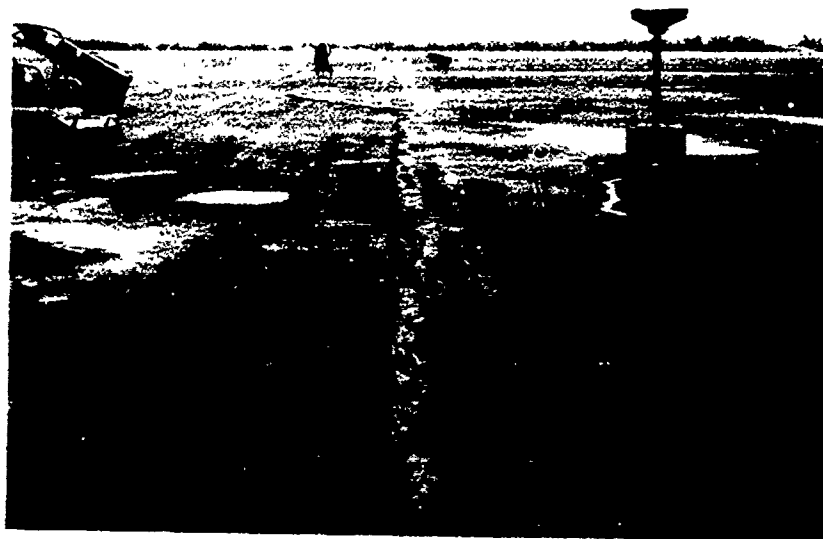
Photo 17. Tar-rubber constructed in 1971 on left
and in 1964 on right; Selfridge AFB

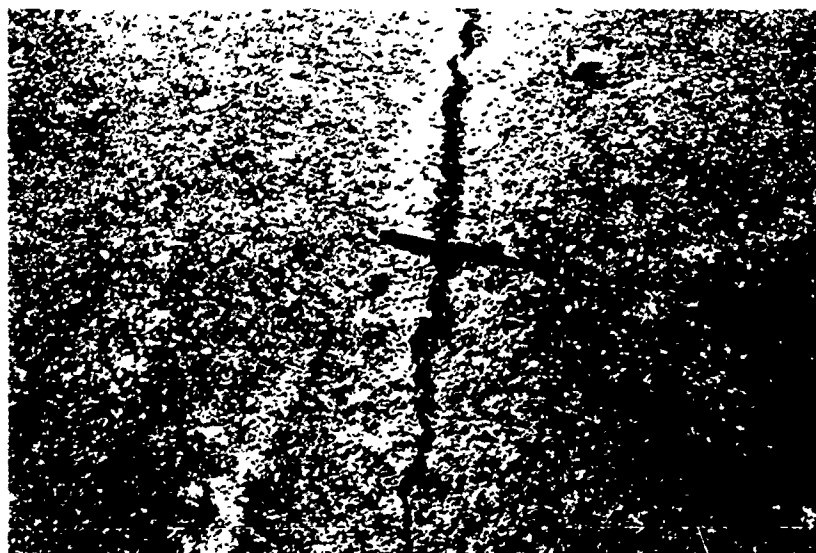
19. The parking aprons surfaced with tar-rubber had been used by C-130, C-135, and transient-type aircraft. The pavements were receiving very little usage at the time of this investigation. The pavements constructed in 1969 were located in a refueling area on the south apron. They had been sealed with a tar seal and a tar-slurry seal in 1972 (Photo 18). The seal coat had deteriorated on the surface where fuel had spilled (Photo 19). Minor random and reflection cracking was noted in this area. The 1971 pavements, which were used by C-130 aircraft from 1971 to 1974, contained reflection and shrinkage cracks (Photo 20). The 1972 pavements on the northwest apron contained reflection cracks, and, in some areas, water was seeping out of the cracks (Photo 21). The construction joints were not well sealed (Photo 22), and cores obtained

Photo 21. Reflection crack in Forbes (1972) pavement
with water seeping from crack

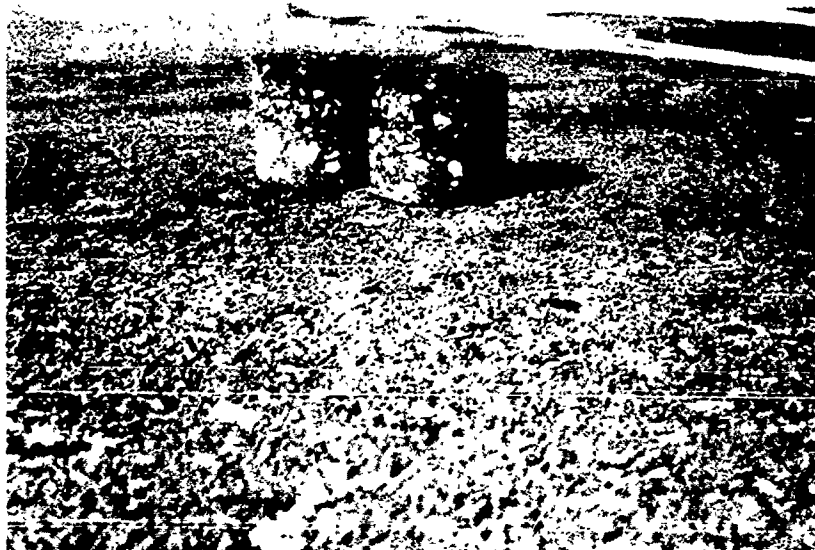
in the center of the paving lane indicated a high percentage of voids (Photo 23). The 1973 pavements were in good condition, with a good surface texture (Photo 24) and apparently good construction joints (Photo 25), though some hairline reflection cracks were noted on the surface.

Photo 23. Cores taken out of Forbes (1972) tar-rubber and tar binder (Note large voids in surface course.)

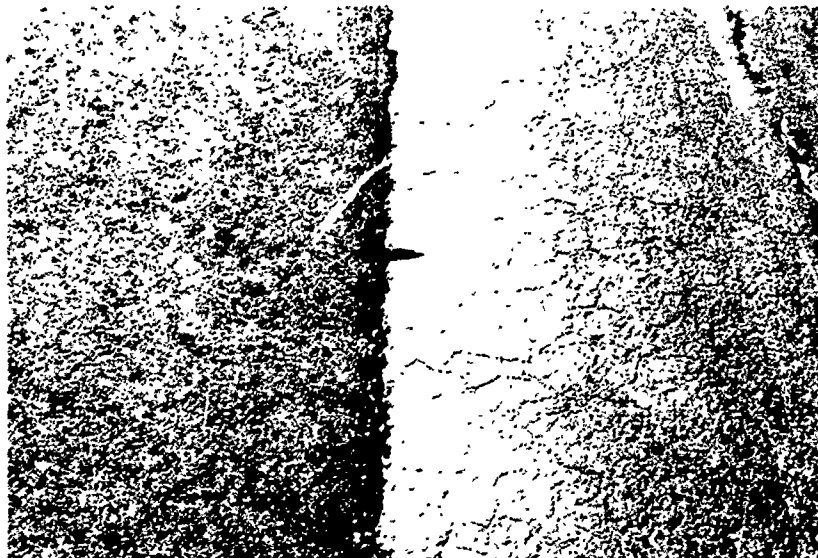
Photo 29. Surface texture of Mountain Home (1970)
pavements; tar-rubber on left and asphaltic
concrete on right

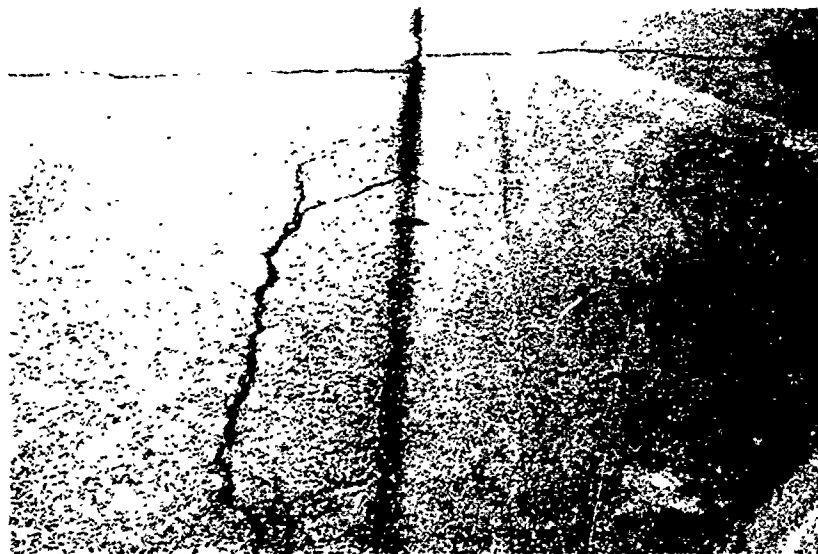
21. The pavements constructed in 1968 were not being used by aircraft at the time of this investigation, but they had been used as a parking area for F-4 aircraft. Two or three seal coats had been applied to the surface, but fuel spillage had deteriorated the seal in aircraft parking areas (Photo 26). Several areas where F-4 aircraft had been parked had been depressed and damaged; therefore, they had been removed and replaced with PCC (Photo 27) in 1971. Roofing felt had been used in two strips as a bond breaker between the PCC and the tar binder for protection against reflection cracks. However, during construction, the felt had moved under rolling and prevented proper compaction and thus had not prevented reflection cracking from appearing at the surface (Photo 28). The 1970 tar-rubber pavements had not received a seal coat (Photo 29), and considerable reflection cracking and open construction joints in need of sealing were noted (Photo 30). Lack of compaction at the joints during construction was quite evident.

Photo 30. Reflection cracking and cracking in
construction joint of Mountain Home (1970)
pavement

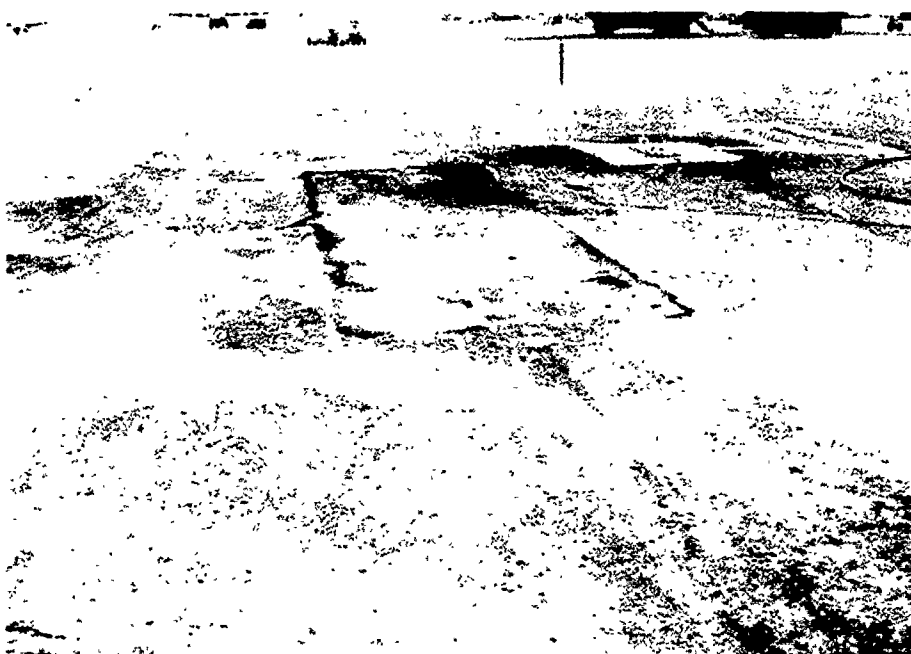
Photo 32. General deterioration in Langley (1966)
fighter aircraft parking area

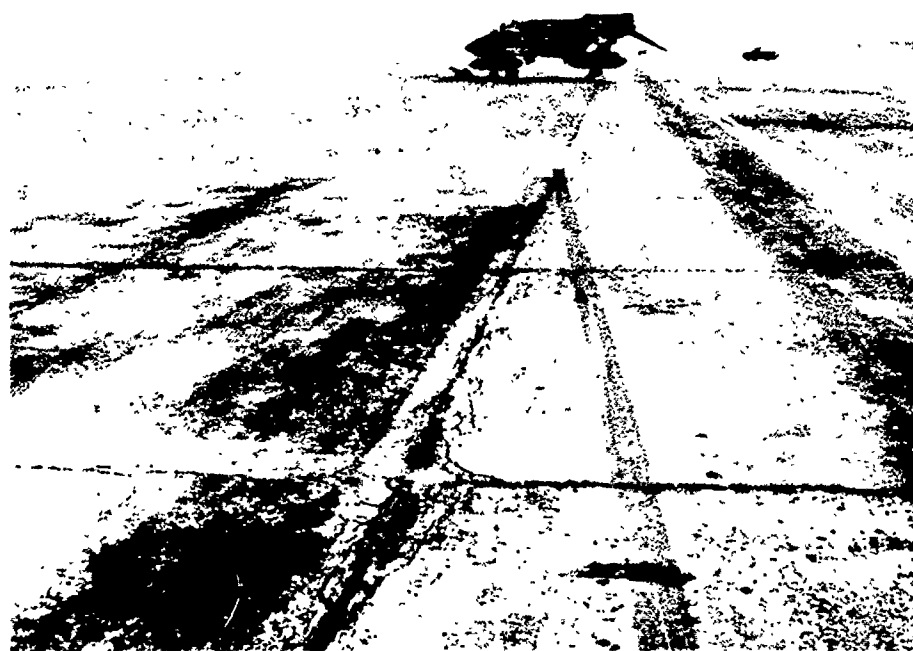
25. The pavements constructed in 1960 were located on pavements identified at the time of this investigation as taxiways 8 and 12. The outer edges of taxiway 8 had been used for parking aircraft, mainly the F-4, F-5, and T-38. The pavement in the immediate parking area was in poor condition, with deterioration in the surface from fuel spillage and high tire pressures (Photo 36). Pavements in taxiway 12 had not been

Photo 36. Outer edge of Wright-Patterson (1960) taxiway 8 used for parking of aircraft

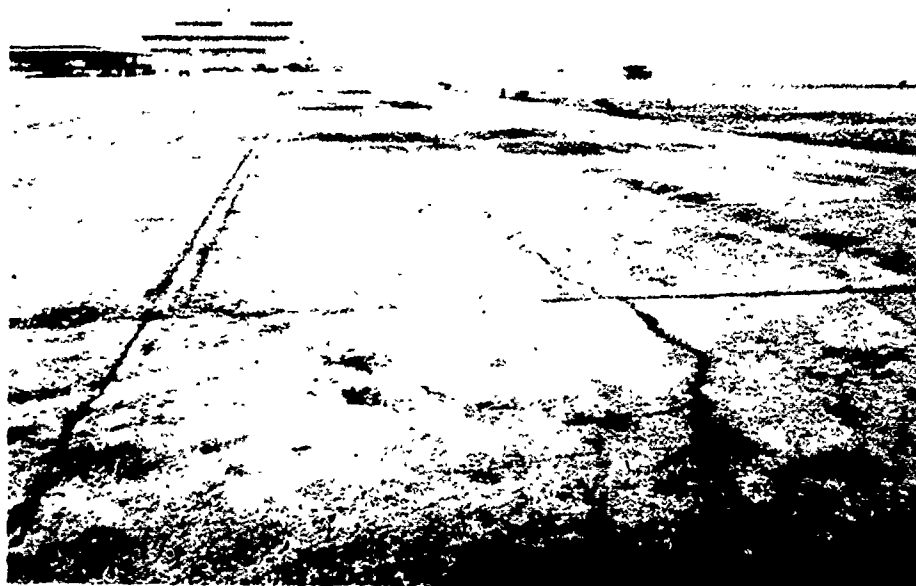
Photo 40. General deterioration of Wright-Patterson (1966)
pavement from cracking and fuel spillage
